PHASE V
MARINE SEISMIC SYSTEM (MSS) DEPLOYMENT
FINAL REPORT

An investigation of techniques and deployment scenarios for installation of triaxial seismometer in a borehole in the deep ocean.

ROBERT L. WALLERSTEDT
PROJECT ENGINEER
GLOBAL MARINE DEVELOPMENT INC
2302 MARTIN STREET
IRVINE, CALIFORNIA 92715

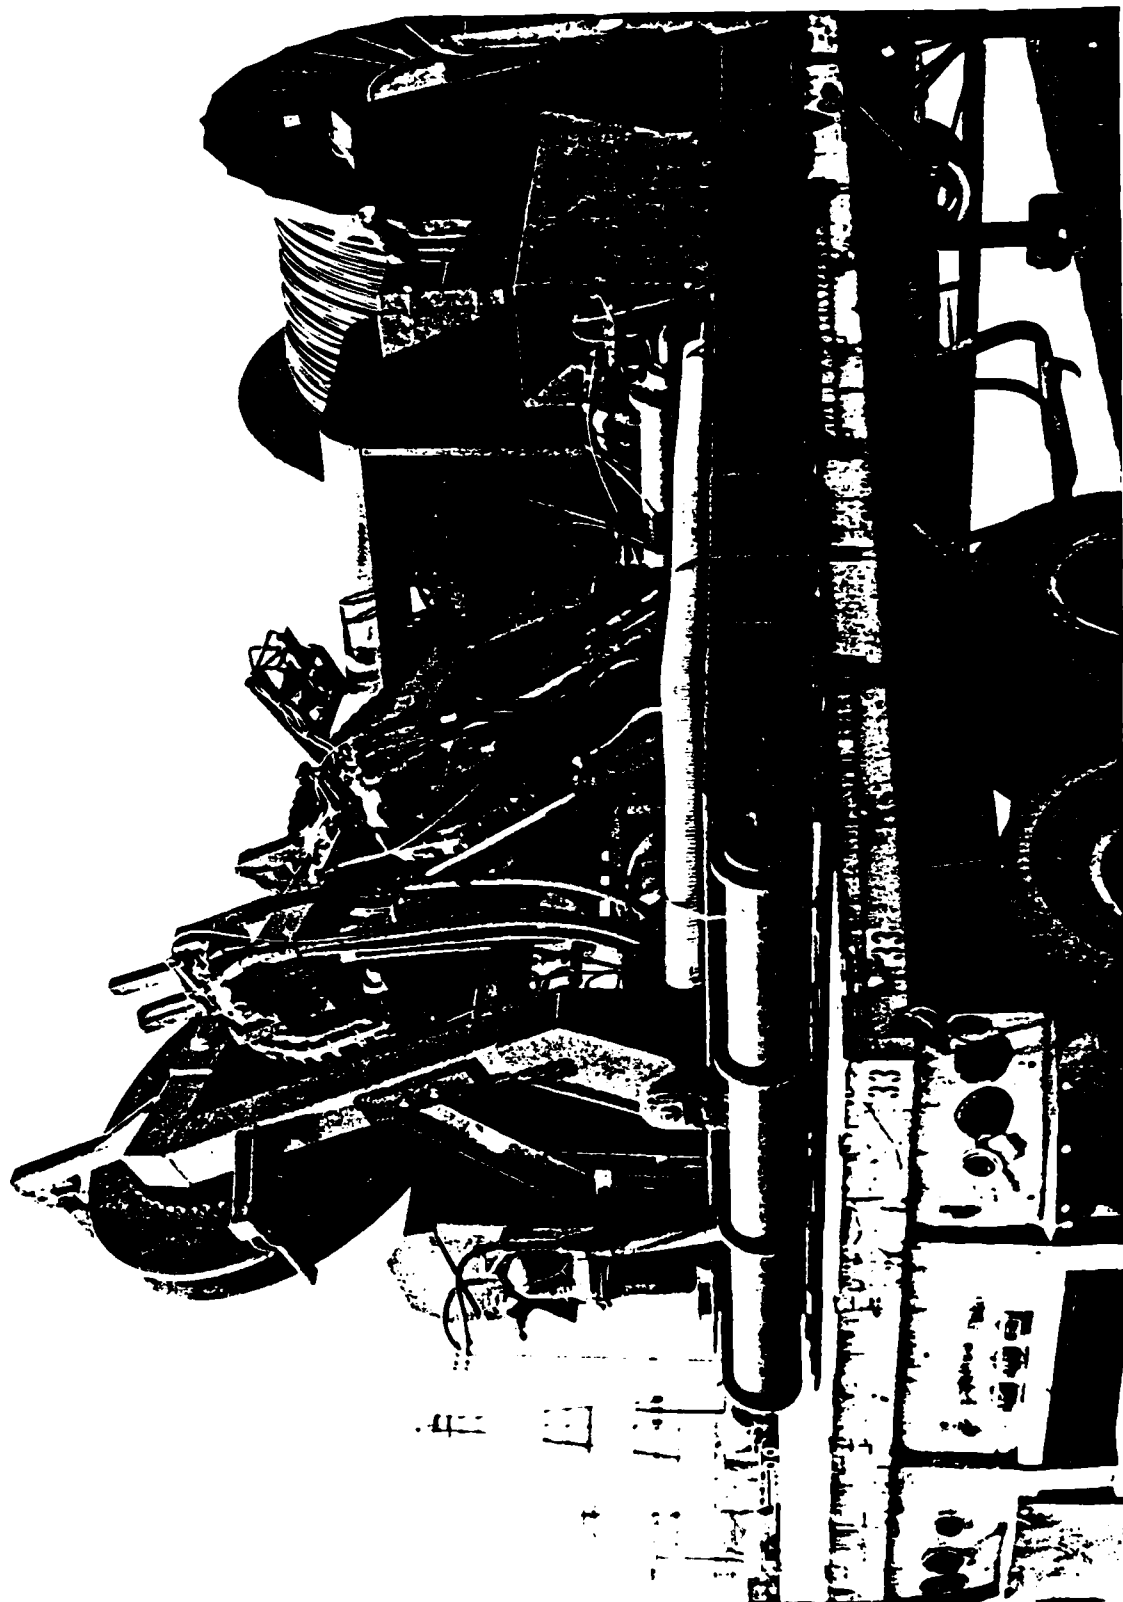
FIGURE 4-3 PENGUIN JINCH

The winch is 2.8 m high by 2.3 m wide by 5.9 m long (9 ft x 7.5 ft x 19.4 ft). Mounted to a specially welded deck foundation, the winch weighs about 17,300 kg (38,000 lbs) when loaded with cable. The reel can carry approximately 9,000 m (29,528 ft) of 1.58 cm (.62 in.) cable; maximum loading is approximately 6,800 kg (14,960 lb).

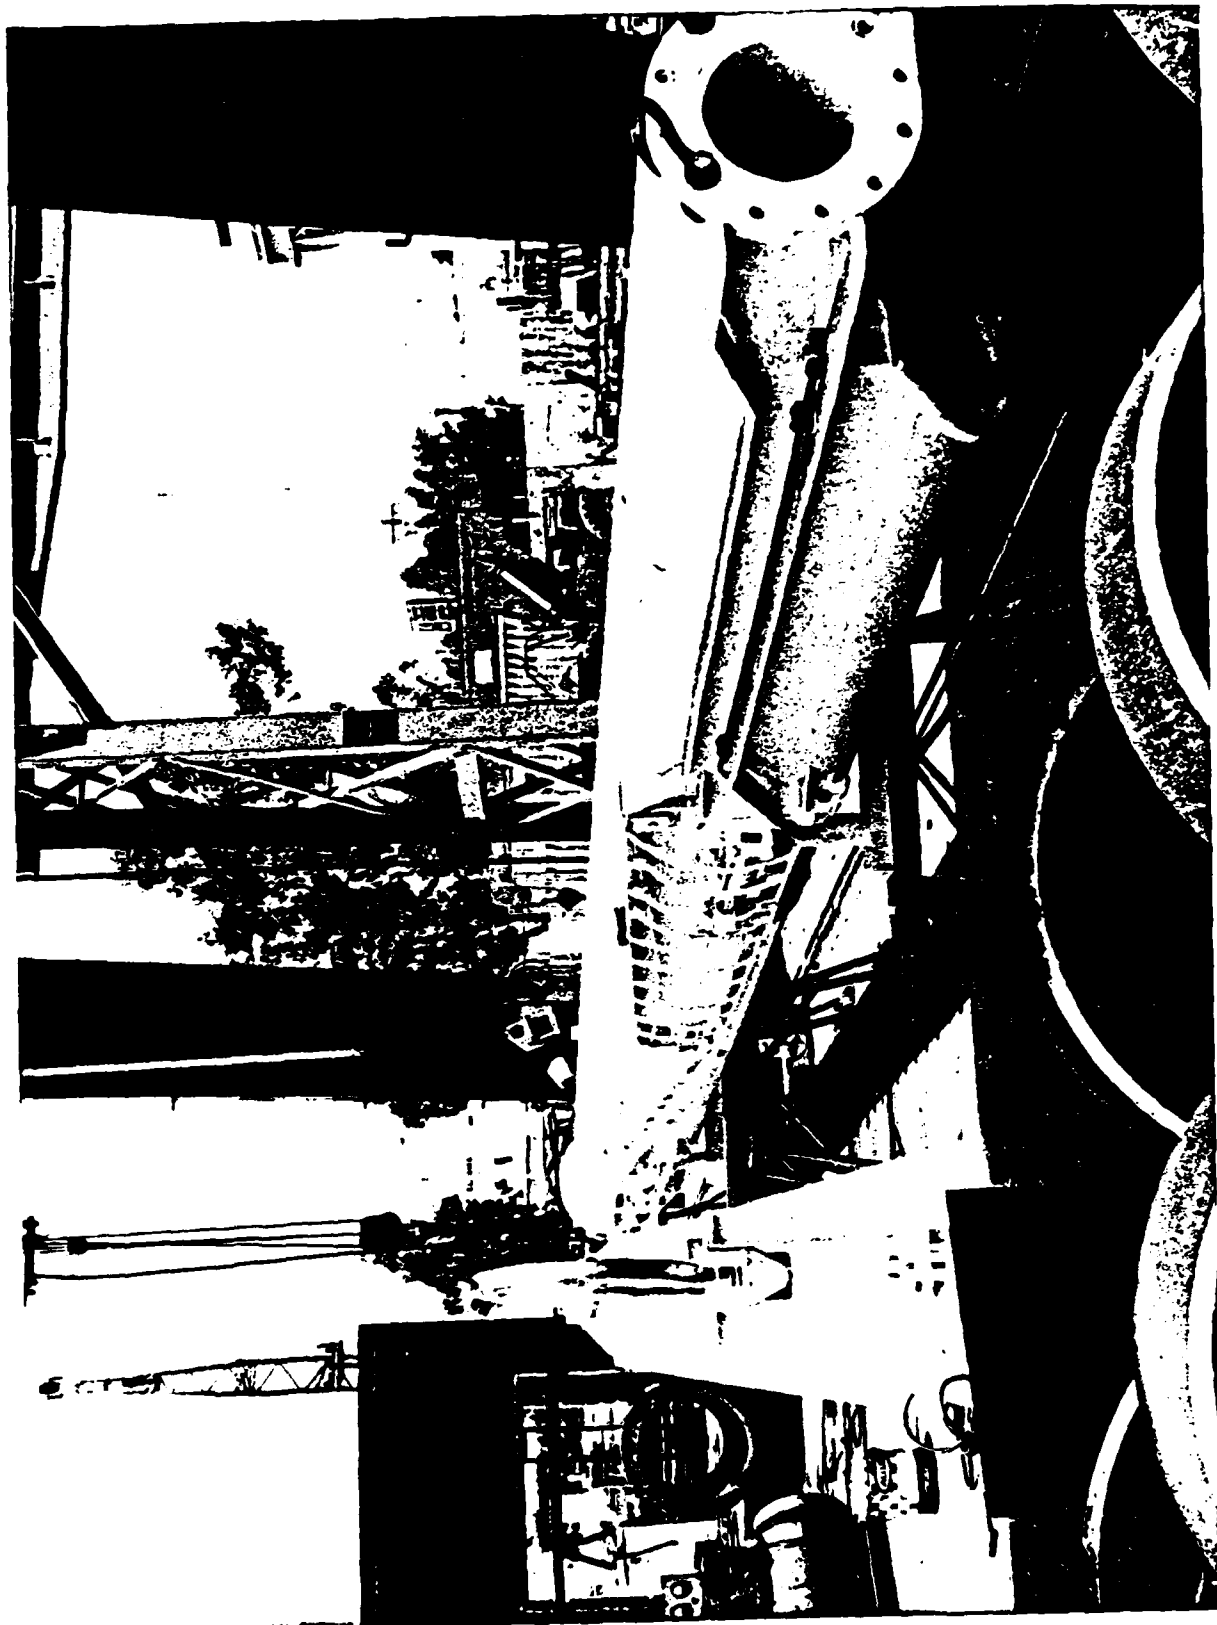
FIGURE 4-11 REENTRY HOUSING

The BIP carriage housing was lengthened by 1.52 m (5 ft) to accommodate the redesigned longer BIP. The carriage lug shear pin arrangement was also improved for easier installation of the shear pins. The reentry carriage housing is shown on Figure 4-11. The MSS '82/'83 BIP was equipped with an isolating centering device which kicks-out locking dogs when there is no load on the EM Cable. A shock absorber lined with stainless steel was installed in the BIP carriage to restrain these dogs during the BIP carriage transfer operation.
